Maximizing the benefit by revival, mordenisation  
and rejuvenation of water harvesting sturcture  
(check Dam) in Dahod District of Gujarat

Lukhawada Check dam across River hadaf, Taluka :  
Limkheda

Funded by :  
Gujarat State Seed Corporation Ltd.,

Implemented by  
Sadguru Foundation-Dahod

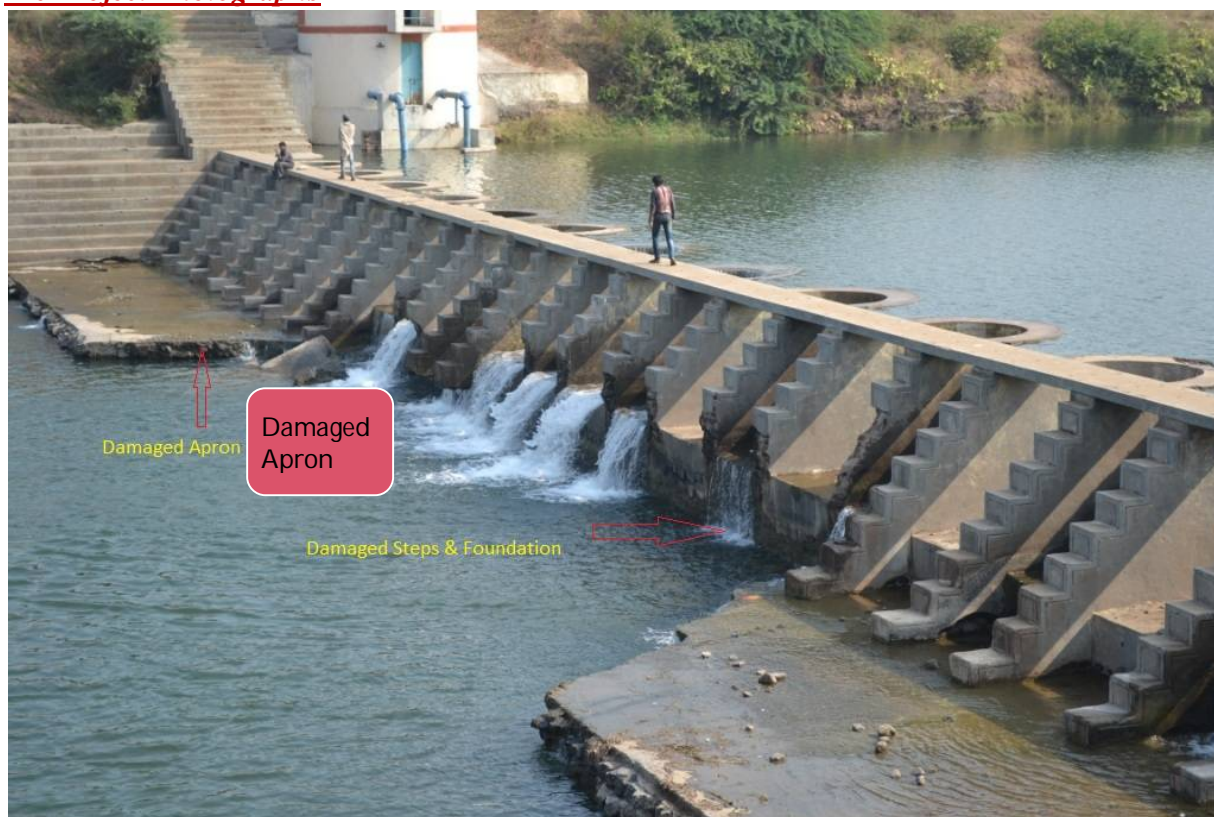
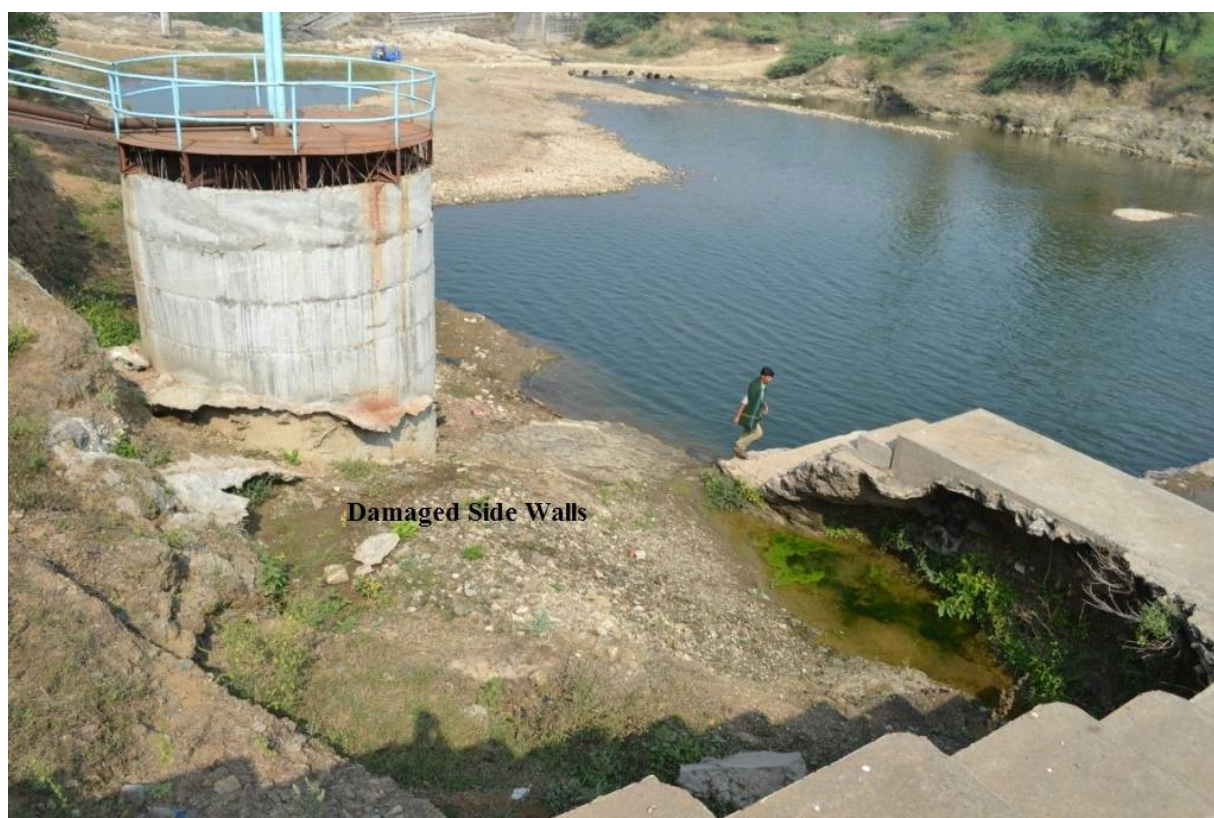
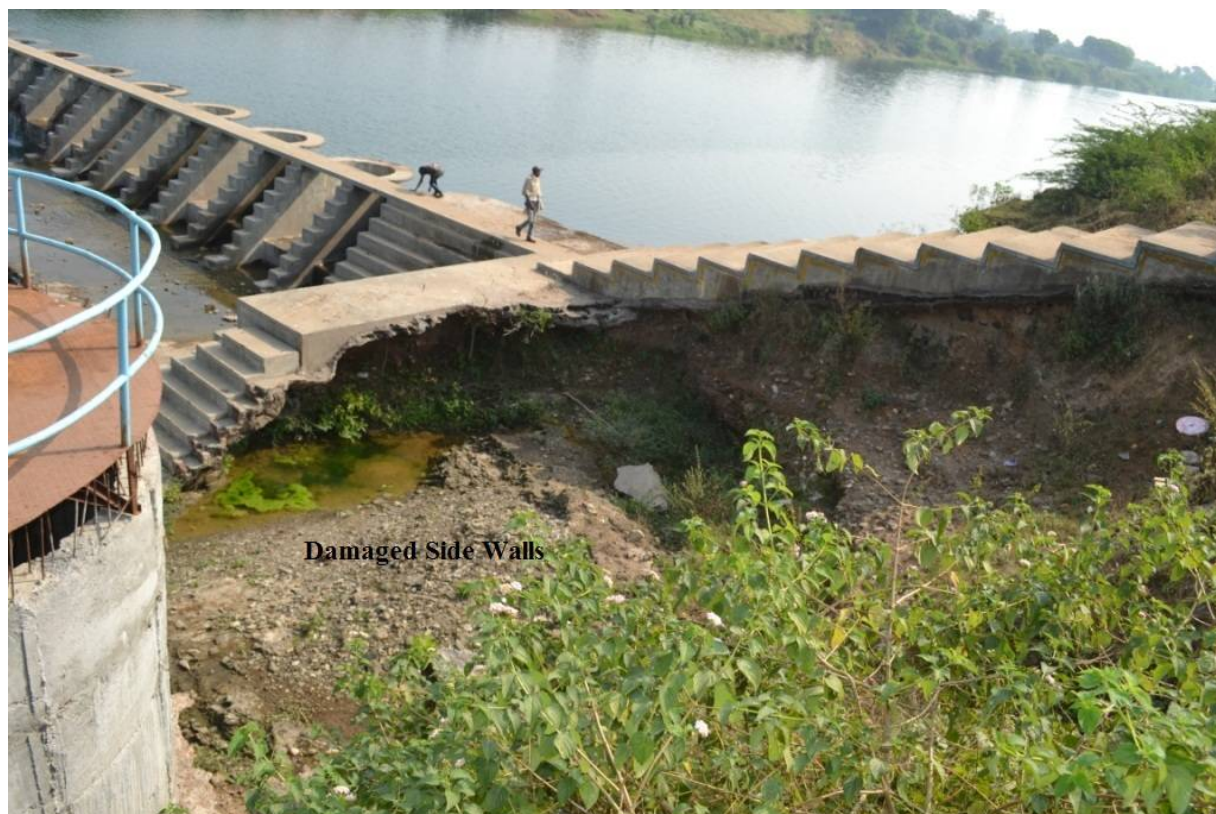
**Pre Project Photographs**

Major repair required is of horizontal Apron, Chambers erosion, embankment strengthening (refilling, pitching, copying) etc. The repair cost would be about **Rs.22.50 Lac.**

- 1) To avoid further damages to check Dam and to keep it healthy for maximizing future irrigation requirement financial support may be provided to Sadguru Foundation for repair of Lukhawada Check Dam.
- 2) Area of agriculture land is undulated and enough quantum of water available for irrigation. Thus drip irrigation is not much feasible and not recommended.
- 3) Apron top cover RCC shall be considered as of M-20 grade instead of M-15 grade for better strength.
